Manhole Inspection Summary

Manhole # S35QQ1011MH

Inspection ☐ Is Incomplete Rating: **4) Poor**

Location Address: **404 WINSTON AVE**

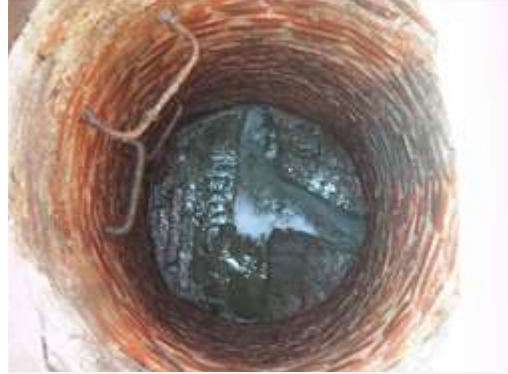
Top View

Corroded steps. Bench and Channel debris.

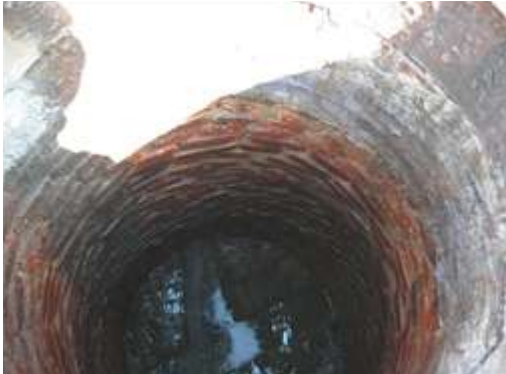
Defect

Frame leaks. Adjustment deterioration and infiltration. Barrel infiltration - other side.

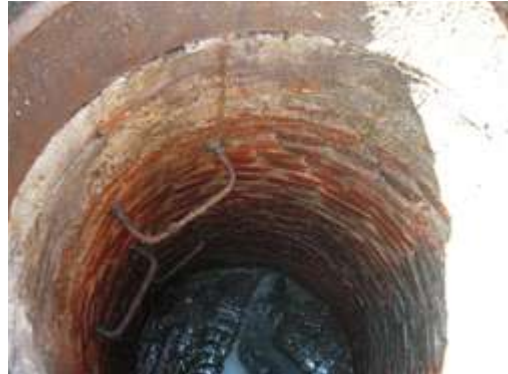
Defect

Frame leaks. Adjustment deterioration and infiltration. Barrel infiltration.

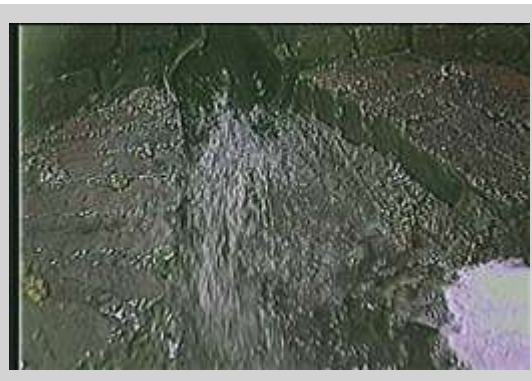
Drop In @ 4 O'Clock

Barrel deterioration and infiltration. Bench and Channel deterioration.

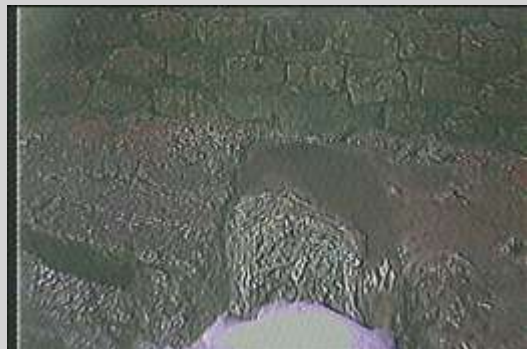
Pipe In @ 6 O'Clock

Barrel deterioration and infiltration.
